Private Stately Home

Refurbishment and New Leisure Works

Project Background

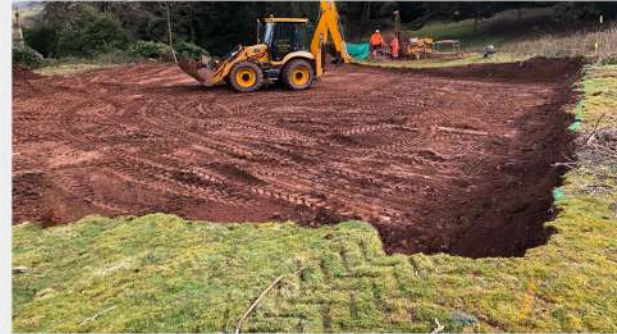
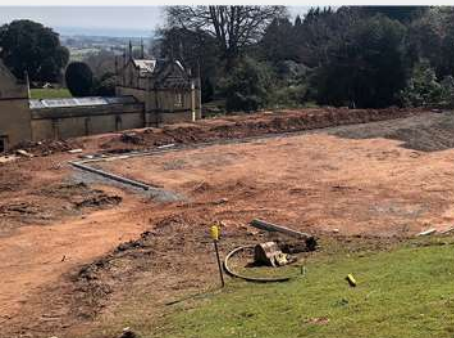
The first process was to set out the area and steak it out. We then reduced levels using machines and a laser level. The spoil was set aside for reuse by the landscapers on site. A batter was formed due to the differences in levels. The area was civilized, checked for levels and rolled.

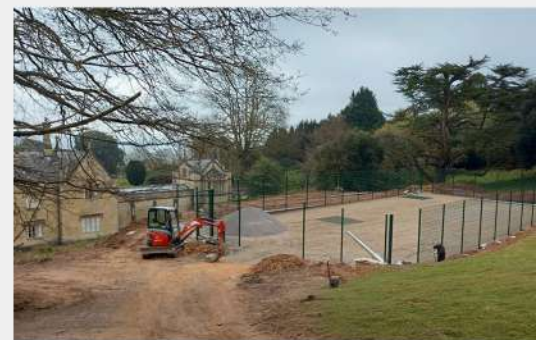
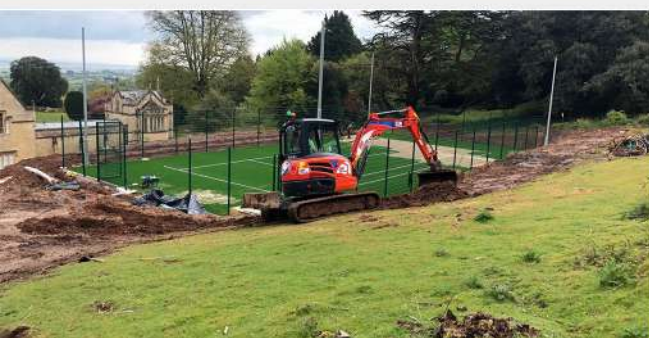
Once the edgings and the stone had been complete the installation of the fencing commenced. At this point we also formed the bases for the floorlights out of formwork and concrete and had western poer install the new power supply. A distribution boar and meter was installed into a timber built shed.

With the fencing complete compaction of a 30mm 6mm to dust screed layer was added to the stone and the artificial grass was fitted. The line markings were cut into the grass and silica sand was brushed into the grass to help with drainage and traction. The floodlight masts were erected.

The external perimeter of the site was set out and marked again. A heavy duty weed membrane was laid and Type 1 stone was imported and edgings were installed, land drainage was also installed at this point.

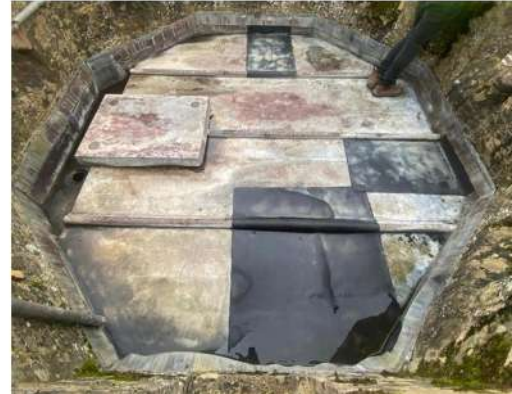
Damage had been caused to a ceiling in the turret of this home. Trident were instructed to erect a scaffold and investigate the issue it became apparent that an attempt had been made, to repair a section of damaged lead roof with a rubber roofing membrane that was not fit for purpose or compatible. We liaised with the architect and other authorities and we were instructed to repair the roof back to its original glory.

The lead was removed and safely lowered to the ground and we discovered that some of the existing deck had become damaged. The scaffolders were called in to add further safety measures which would allow us to replace the deck. The joists were also replaced and the deck reinstated with penny gaps and correct falls for drainage

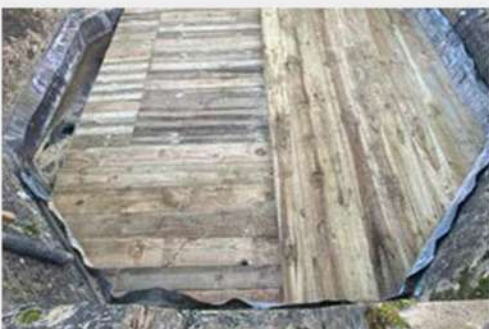
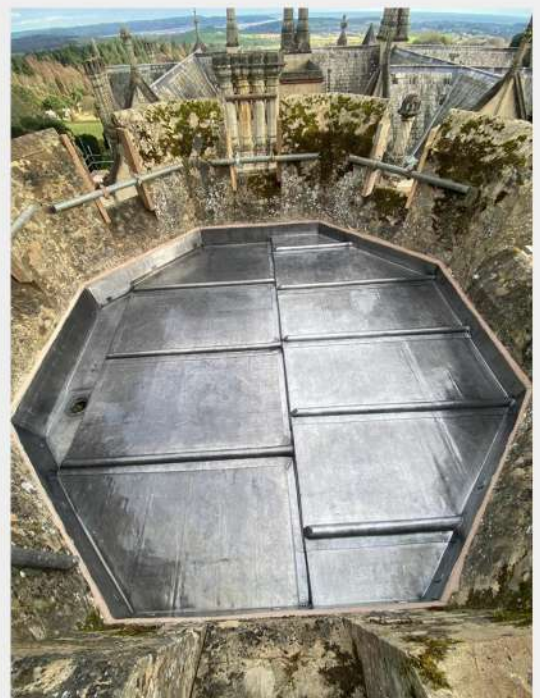
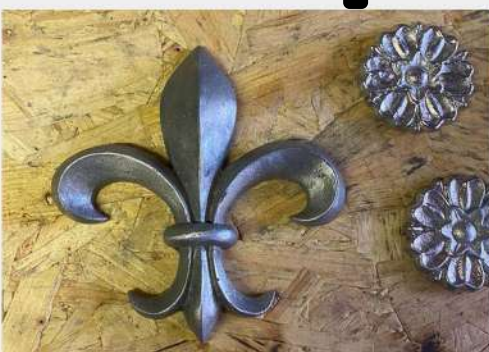
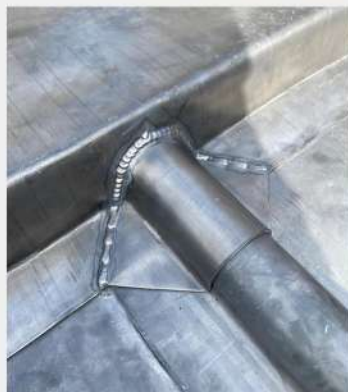
Once the deck was ready to receive the lead, bays were calculated and formed with mop stick hand rail. The lead was cut at ground level, lifted up and laid with skill and care inline with the current code of practice. The lead was welded where necessary and cut into the existing channel in the stone work. Lime mortar specified by the architect was used to point. The lead was then cleaned and coated with patination oil. The finished roof was inspected and approved before striking the scaffold.

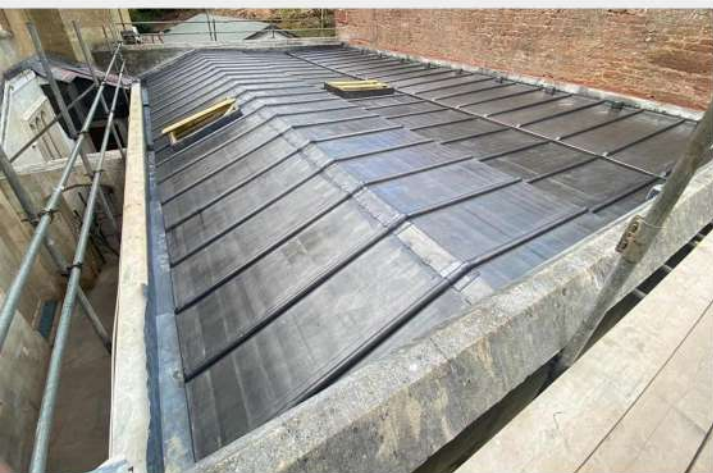
Lead Roof Renewal

We have renewed a number of lead roofs using similar techniques to the turrets across the site that were leaking and causing internal damage. All of timber deck, gutters and lead were replaced as part of the works

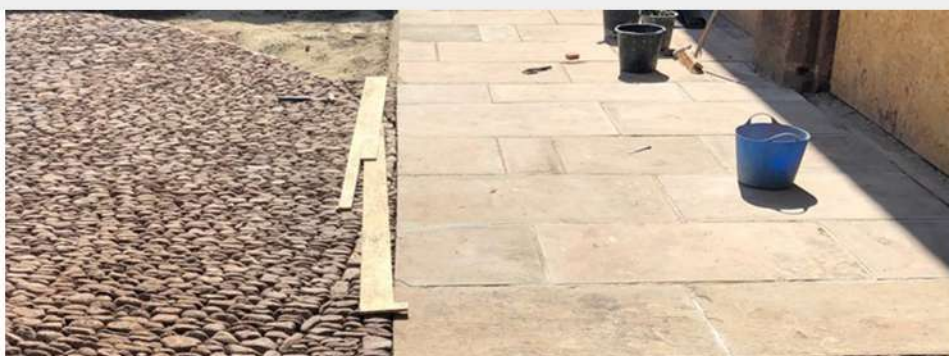
External Works

Supply and fit of York Stone and Cobbles. These were sourced locally to match existing

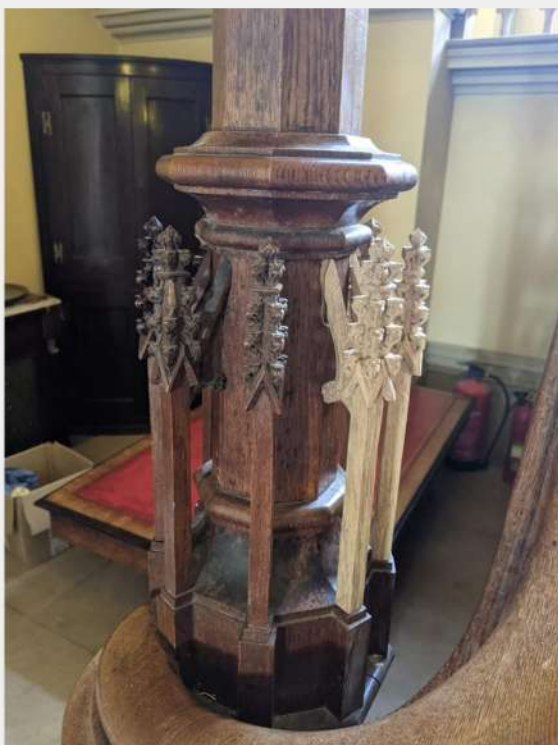
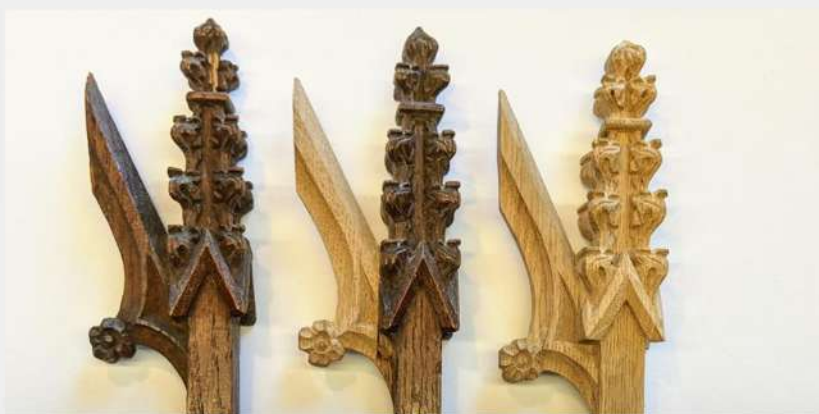
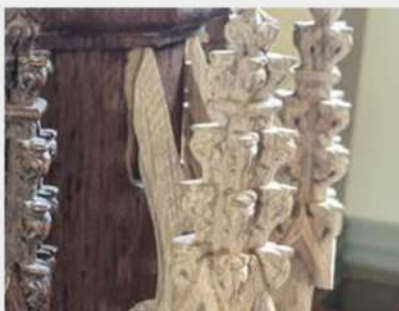
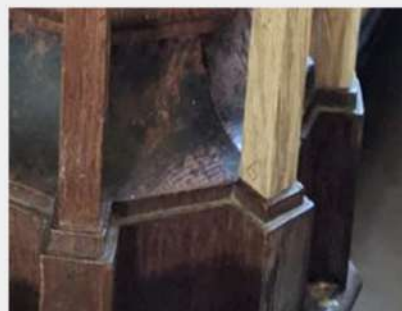
Restoration of Staircase

Bespoke carvings to the original staircase had been damaged/snapped off. We were instructed to replace these decorative oak carving's and stain to match the existing.

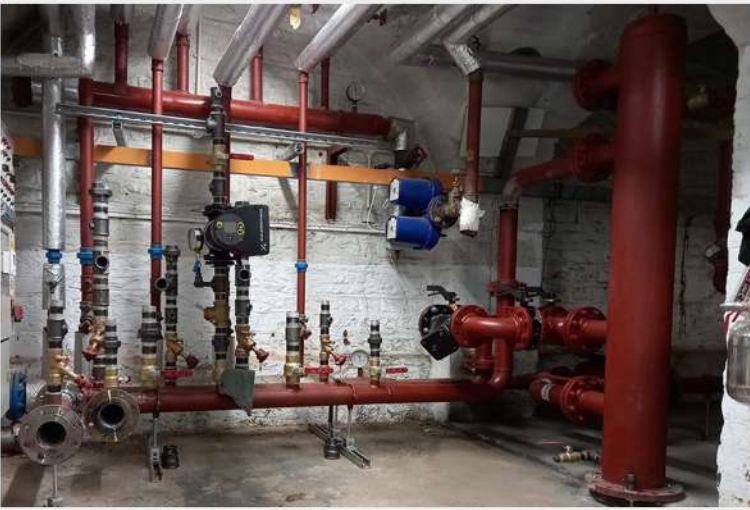
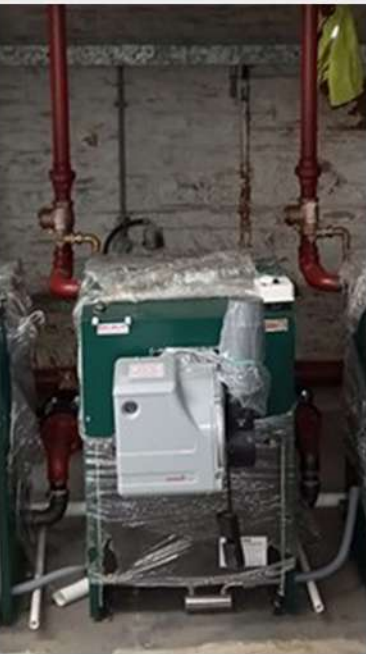
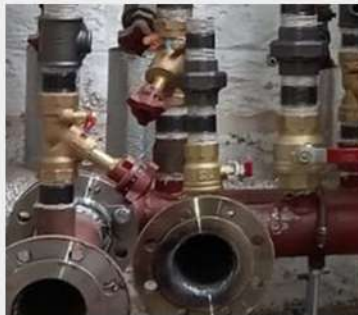
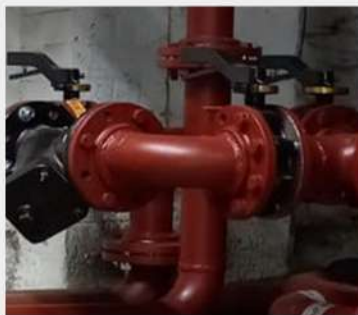
New Boiler and Plant Room Installations

- Isolations, drain down and clearance of existing basement plant room.
- Positioning of 3no new boilers, pipework alterations.
- Alterations to pipe work to enable zoning modifications.
- Remove and replace flue.
- Installation of 3no. GRP oil tanks
- New BMS and smart controls
